Hurricane Damage Repair Required Careful Timing

New Providence officials balanced numerous deadlines and requirements to replace storm drains

By Allen Morgan,
Mayor, New Providence

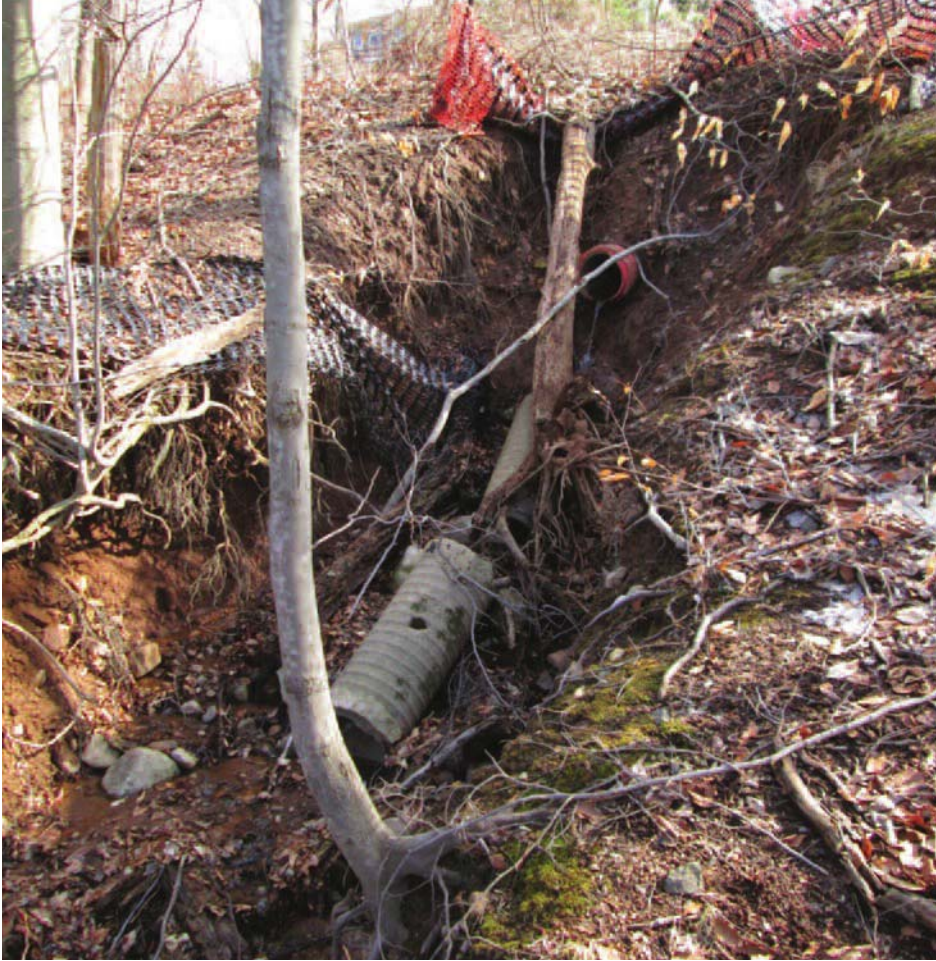
After re-grading, the slopes were stabilized by installing a 100 percent coconut fiber erosion control blanket held together with 100 percent biodegradable jute netting and 100 percent biodegradable stakes made of bio-plastic resin.

Flooding in municipalities along the Passaic River wreaked as much havoc on stormwater systems as it did on fixed annual infrastructure budgets.

After re-grading the slopes (up to 2:1), we stabilized them in the most environmental friendly way possible by installing a 100 percent coconut fiber erosion control blanket held together with 100 percent biodegradable jute netting and 100 percent biodegradable stakes made of bio-plastic resin to hold the blanket to the ground. This blanket protects the seed, increasing the germination rate, while providing temporary stabilization until vegetation is permanently established. Since the site is in a wooded area, we specified a Conservation Shade Mix specifically composed of grasses that are shade tolerant, which helped stabilize steep slopes.

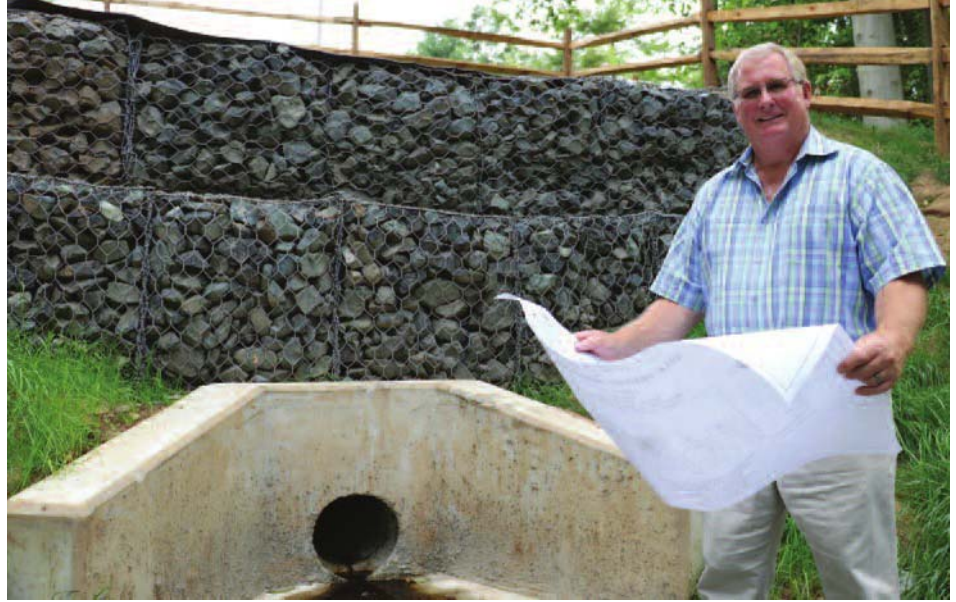
New Providence Mayor Allen Morgan looks over a completed storm drain.

Consulting P.A., our design included the replacement of the previously washed-out manholes, stormwater pipes and headwalls with new ones, backfilling the eroded areas, and re-stabilizing the areas with rip rap at the outfalls.
